2022 QUINQUENNIAL INSPECTION SURVEY REPORT

PRESTON-UNDER-SCAR: CHURCH OF ST MARGARET

Preston-Under-Scar Church of St Margaret

Diocese:	Anglican Diocese of Leeds
Archdeaconry:	Richmond and Craven
Contact:	Hilary Grisewood
Date of Inspection:	28 th June 2022
Date of Last Inspection:	10 th April 2017
Limitations:	The inspection was carried out from ground level using binoculars both inside and out where necessary. Ladders were not available. Compass bearings throughout this report refer to ecclesiastical orientation. Window reference numbers, where given, refer to the CVMA (Corpus Vitrearum Medii Aevi) system.
Disclaimer:	Woodwork or other parts of the structure which are covered, unexposed or inaccessible have not been inspected and therefore it is not possible to report that any such part of the building is free of defect.

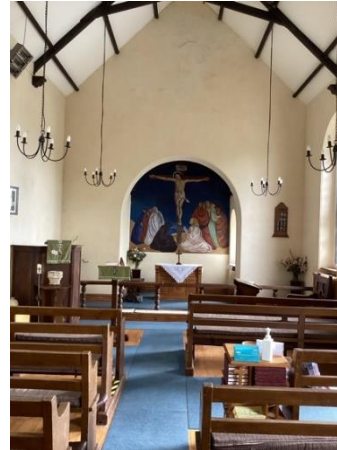
- 3.1 The roof consists of slender scissor trusses with no bottom cord, intermediate purlins, and plastered between. There is a little discolouration at each of the gable ends. It is assumed that this is the result of moisture coming from the walls where there have been problems in the past. Once the walls have dried the area can be redecorated with a breathable paint. There are no other signs of damp within the roof structure.

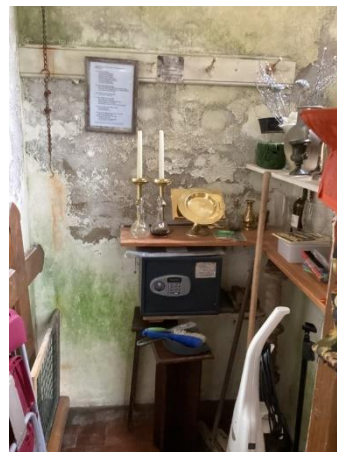
The small Vestry at the back of the church is very simple. Plastered and painted with a quarry tiled floor. There is evidence of damp, although it does appear to be drier than it perhaps has been in the past. This is no doubt due to the ventilation holes which have been added. The loose plaster and paint should be brushed off with a very stiff wire brush, and the area observed over the quinquennium to see if things improve. The plaster appears to be quite hard, which suggests that it might not be appropriate for the area, but if it dries out all may still bewell.

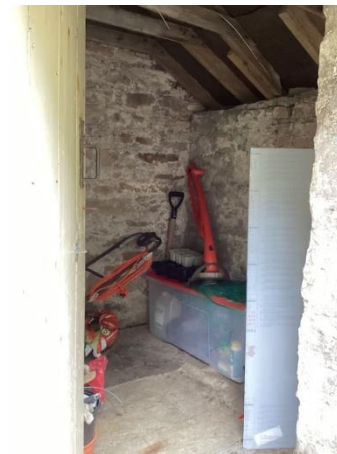
Stone lined room with a timber roof. Works have been carried out to the roof to replace some of the rafter ends, and the roof is felted. All appears in fair condition and is again used for storage.

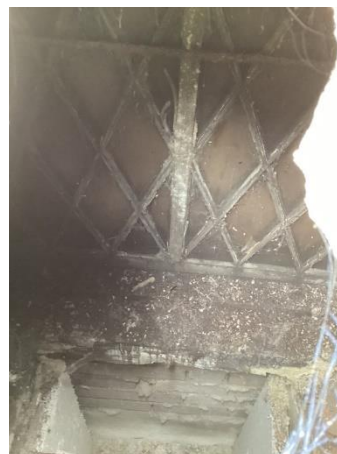
- 3.22 The slot chamber to the north of the church is covered by large stone slabs and may have housed some of the former heating system. It also houses the remains of the now covered northern window. It is tempting to suggest that this slot is reopened to allow the northern window to be fully exposed. However, the situation at present seems to be stable and the slot appears to remain dry with little evidence of damp ingress at this point. As such, maintaining the status quo would remain acceptable.

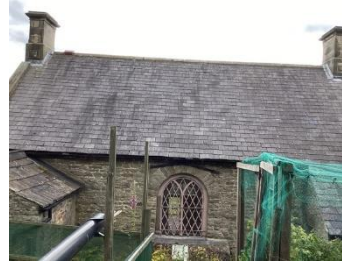
The main building has a Welsh slate roof, with stone ridge and stone copings. There are a few slipped and chipped slates with a few tingled repairs.

- 4.1 There are several slipped slates on the under course which are now sitting in the gutter on the north side. These should be removed from the gutter and refixed.

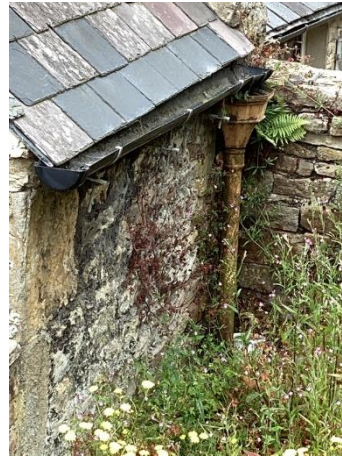
- 4.12 The drainage from the Vestry should be investigated. The existing cast-iron downpipe requires repair, but the system needs to be inspected for leaks. If it is leaking, it has the potential to increase the dampness in the Vestry, which should be prevented where possible.

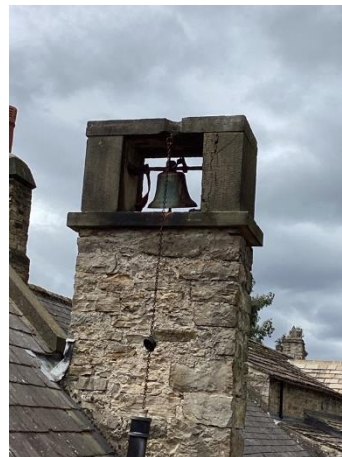
The bellcote is of significant concern. There is a fresh fracture running through the upright to the north side, and the mechanism is extremely rusty. This begs the question as to how well the mechanism is still secured into the bell structure. The bell should not be rung until a stonemason has been able to assess the stability of the stonework and potentially repair the bellcote. Prior to resuming ringing, the bell mechanism required derusting and redecoration.

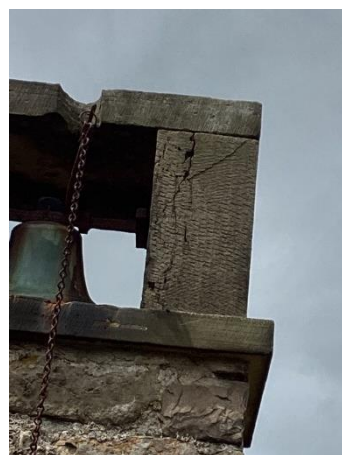
- 4.14 When viewed through binoculars, the fracture appeared quite fresh, and it has very likely been caused by the rusting bell mechanism splitting the stone part. The stability of the entire bellcote should be assessed.

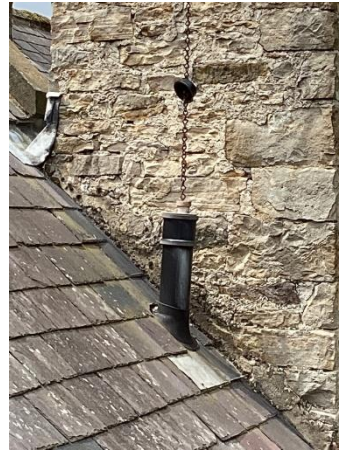
- 4.15 The cap to the air pipe preventing water ingress should be replaced.

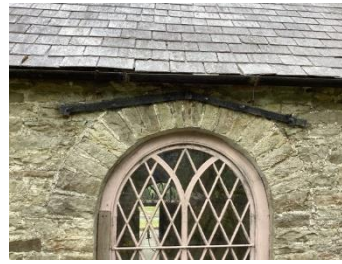
- 4.19 Steel strap over the northern window should be redecorated.

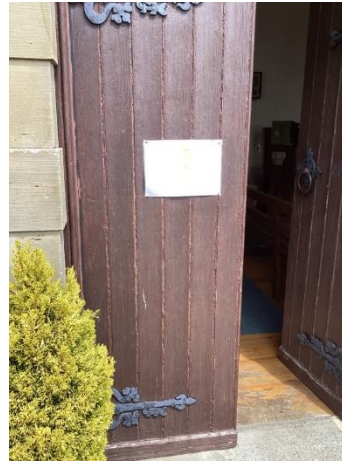
- 4.23 The front doors, particularly the ironmongery, would benefit from redecoration.

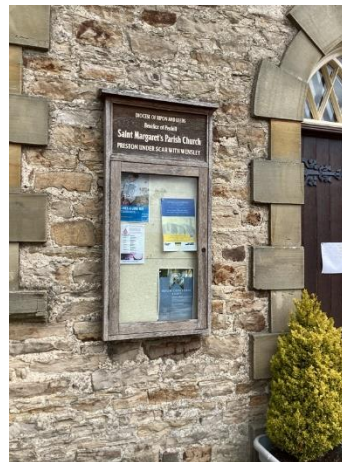
- 4.24 The noticeboard would benefit from redecoration.

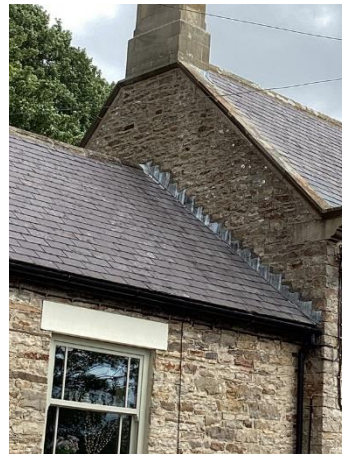
- 4.25 Of what could be seen of the west wall, all appeared in fair condition. The pointing seems to be tight, and the stonework appears to be holding up well.

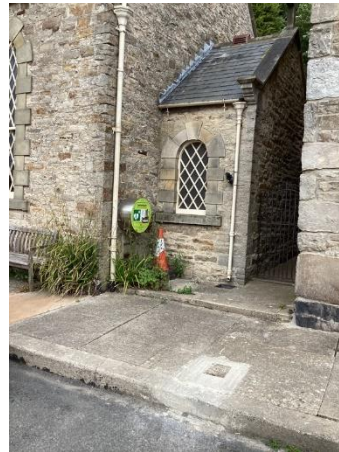
There is very little land associated with the church. The church fronts straight onto the pavement, which faces the main street, and at the back there is access to the allotments beyond. This rear access also appears to be shared with the neighbours.

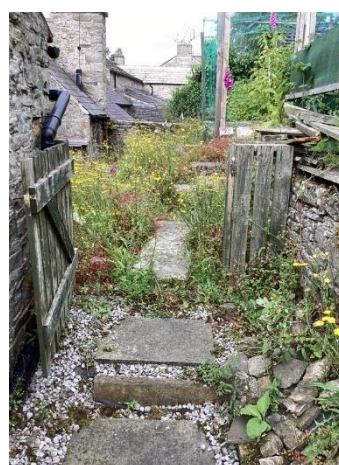
- 4.29 Access to the rear of the church is very uneven and overgrown. While this area may not be church property, if it is, it should be cleared, and access improved.
